Order of Manitoba Public Utilities Commission and Report

Investigation for Stray Electric Currents in the City of Winnipeg and in Adjoining Municipalities

To H. A. ROBSON, Esq., K.C., Public Utilities Commissioner of the Province of Manitoba, Canada By ALBERT F. GANZ, Consulting Engineer

WINNIPEG:
Printed by James Hooper, King's Printer for Manitoba
1915

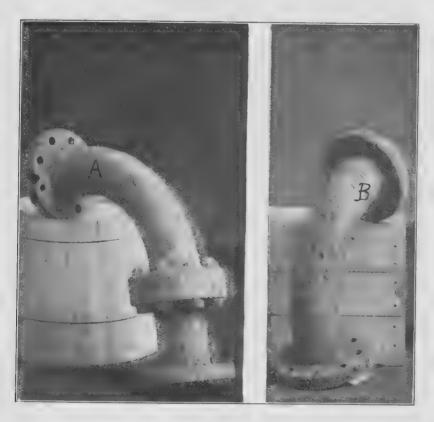
Fig. 2

Corroded Cast-Iron Connecting Pipes from High-Pressure Water Main Removed from Portage Avenue at Hargrave Street, October, 1914

region, and it is probable that this main was corroded to its present state by electrolysis at that time.

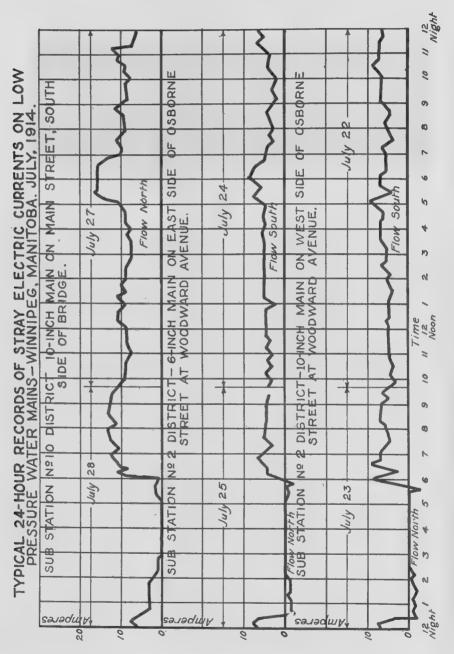
Fig. 4

Three 24-hour records of current flow on water mains are shown plotted in fig. 4. These records are typical of all current records that were obtained on the water mains. Comparing these current records with the records of voltage drop in the street railway tracks, shown in fig. 1, the striking similarity between the records of current flow on the

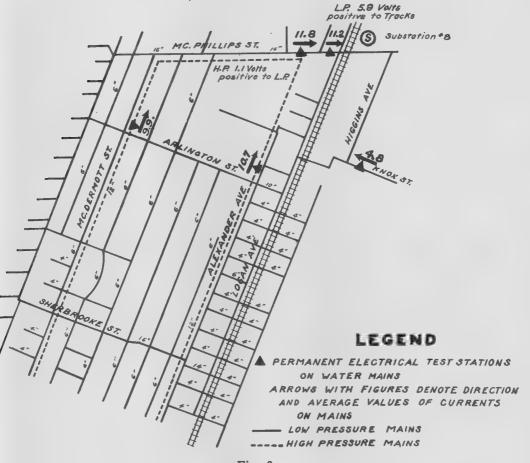
Fig. 6

It will also be noted from table No. 5 that the low- and high-pressure water mains were at practically the same potential at nearly all points tested. One exception to this was on McPhillips street, where the high-pressure water main was 1.1 volt average positive to the low-pressure water main. This low-pressure water main on McPhillips street is itself highly positive to the street railway tracks at Logan avenue in the neighborhood of substation No. 8, this positive potential averaging nearly 6 volts during peak load. There is, therefore, a strong tendency for current to leave the high-pressure main on McPhillips street to flow to the low-pressure main and to leave this latter main to return to substation No. 8 near Logan avenue. The layout of the low-pressure and high-pressure mains in the neighborhood of substation No. 8, together with the current on these mains and of their potential relations is shown in fig. 6. The fact that the high-pressure mains on

STRAY CURRENTS ON WATER MAINS IN VICINITY OF SUBSTATION *8, WINNIPEG, MANITOBA.

Alexander avenue and on McDermot avenue, just east of McPhillips street, were found to carry large stray currents flowing towards McPhillips street, makes it quite evident that there is an actual flow of current from these high-pressure mains through earth to the low-pressure main in McPhillips street with consequent danger to the high-pressure mains from electrolysis. This current must again leave the low-pressure main near Logan avenue, so that it also endangers the low-pressure main in the neighborhood of substation No. 8.

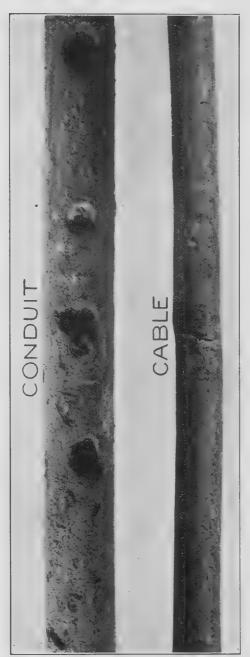
Fig.

- (5) Damage to city's iron service lateral used for carrying the city's fire alarm underground cable into the company's Mill street substation, same being very badly corroded by stray currents; this lateral was laid in 1912.

Corroded and Pitted Iron Conduit and Lead Sheathed Fire and Police Telegraph Cable Contained in this Conduit Removed from Mill Street in front of Substation, July, 1914

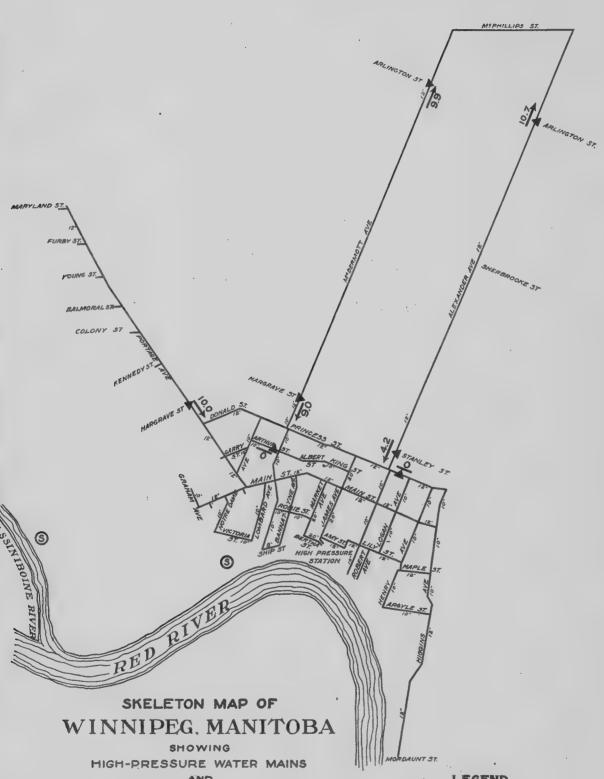
PLATE 3

High-Pressure Water Piping System.—The high-pressure wat piping system is also owned and operated by the City of Winnipeg, at its layout is shown in plate No. 3. This high-pressure system extend through the principal business section of Winnipeg and is used for fine service. It was partly installed during 1906 and completed in 191 Water for it is obtained from the Red River, and the pumping static is located on St. James avenue, near the river. This high-pressure water system comes within the region of stray currents from substation No. 1, No. 8 and No. 10.

General measurements on water piping system.—At every location where a sufficient length of water main was exposed for making a current measurement, a permanent electrical test station was established, by means of which these measurements can be made at any future time without again exposing the main. At these permanent test stations current measurements were made on the water mains by means of a smoked-chart recording millivoltmeter using either a 24-hour or a 1-hour chart. The maximum, minimum, and average values of the currents on the lowpressure water mains are given in table No. 6, and the average values of these currents are shown in plate No. 2. The maximum, minimum, and average values of the currents on the high-pressure water mains are given in table No. 7, and the average values of these currents are shown in plate No. 3. It will be seen from tables No. 6 and No. 7, and from plates No. 2 and No. 3, that at nearly every location where a current measurement was made on a low- or high-pressure water main, stray currents of substantial magnitudes were found flowing towards the nearest railway substation. A particular striking example on this is the case of the high-pressure water mains on Alexander and McDermot avenues, at Arlington street, shown in plate No. 3. On both of these mains current flows west toward McPhillips street. This total current of about 20 amperes must leave the high-pressure mains on Alexander and McDermot avenues west of Arlington street and on McPhillips street and must produce corresponding corrosion of the high-pressure main by electrolysis. On Alexander avenue at Stanley street and on McDermot avenue at Hargrave street, both near substation No. 1, the current flow on the high-pressure water mains is east, that is towards this substation, as seen from plate No. 3.

STRAY ELECTRIC CURRENTS ON THESE MAINS
